Home Inspection Report

**3050 Someplace Dr.
Anywhere, NV 89000**

Prepared By:
Sierra Nevada Home Inspections, Inc.
Sparks, NV 89436
775-425-5341

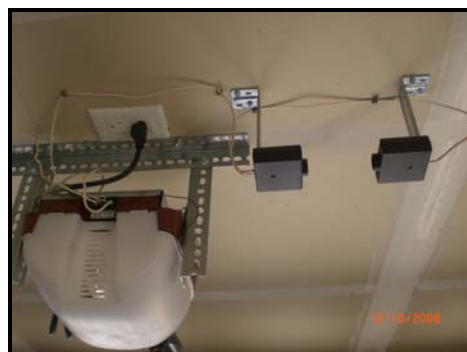
Garage

- **Repair, Safety Issue:** The garage door opener did not automatically reverse under resistance to closing. *There is a serious risk of injury, particularly to children, under this condition.* The sensors have been placed in the garage ceiling to bypass this safety feature and allow the door opener to continue to operate.

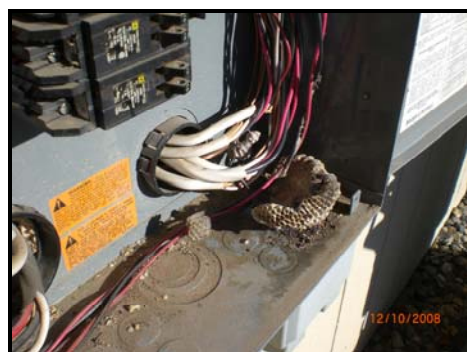
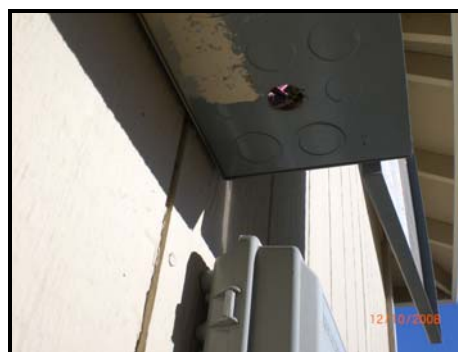
Main Panel

- **Repair:** Any openings in the main panel should be covered. The bottom of the panel has an open knockout which has allowed wasps to build their nests inside the panel.

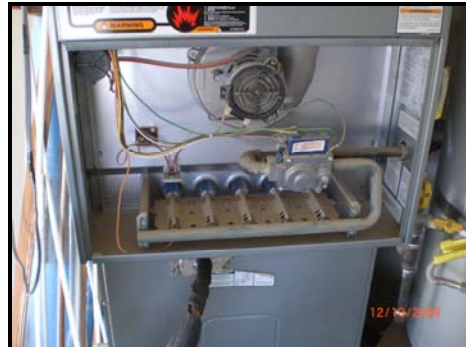
Furnace

- **Repair:** The heating system is dirty and requires cleaning/service. This should be a regular maintenance item to assure safe, reliable heat.

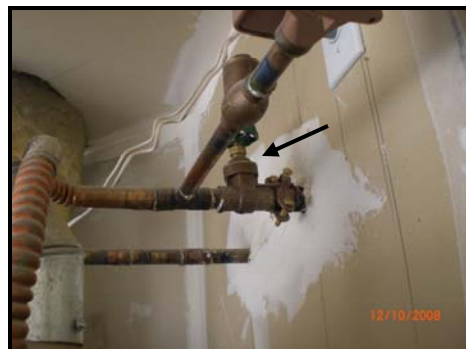
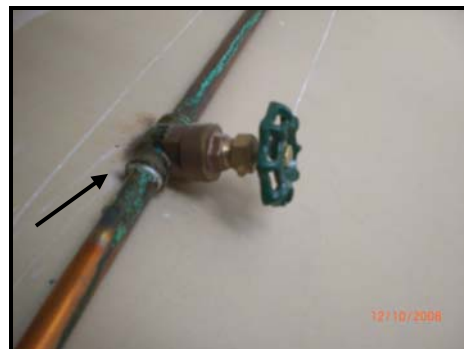
Water Heater

- **Repair:** The cold water inlet valve was leaking at the time of the inspection. The valve off of the circulating pump is leaking and dripping onto the wood below the unit.

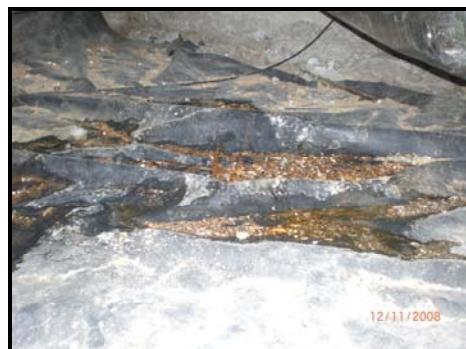
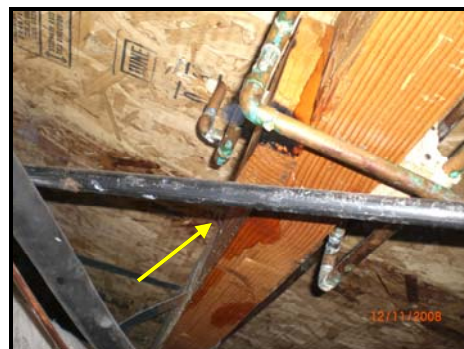
Fixtures

- **Repair:** The utility/laundry room valve is leaking and appears to be leaking down the wall and through the sub floor into the crawl space. The photo on the left is the water from the leak on the vapor barrier.

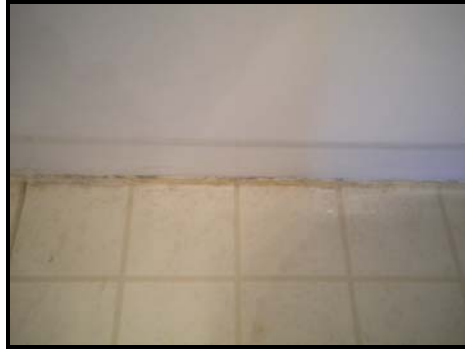
- **Repair:** Cracked, deteriorated and/or missing bathtub enclosure grout and caulk should be replaced in the master bathroom tub.

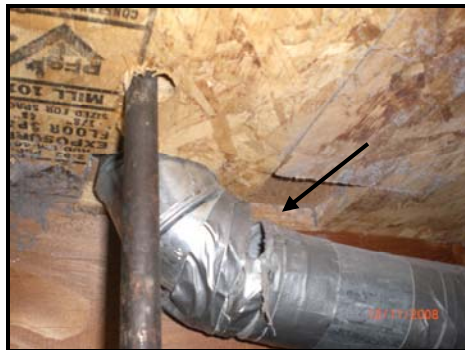
Clothes Dryer

- **Repair:** The clothes dryer exhaust vent pipe has a tear in it and is leaking into the crawlspace. The damper on the exterior vent should be cleaned in order to close properly.

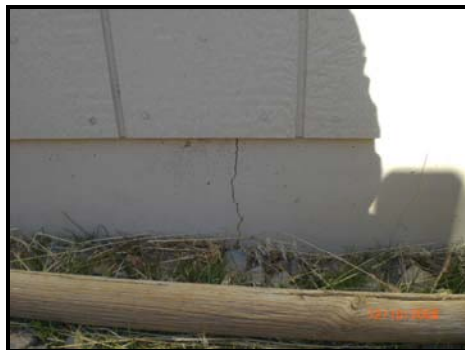
Foundation

- **Monitor:** Common minor settlement cracks were observed in the foundation walls. This implies that some structural movement of the building has occurred. Cracks of this type should be watched for any sign of additional movement. In the absence of any sign of ongoing movement, repair should not be necessary.

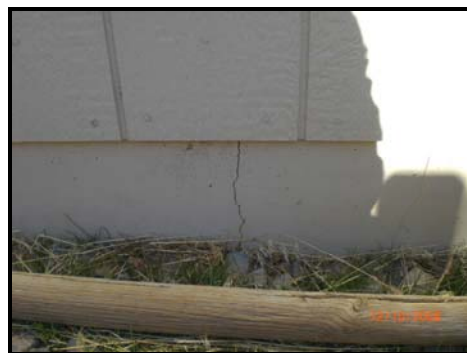
Foundation

- **Monitor:** Common minor settlement cracks were observed in the foundation walls. This implies that some structural movement of the building has occurred. Cracks of this type should be watched for any sign of additional movement. In the absence of any sign of ongoing movement, repair should not be necessary.

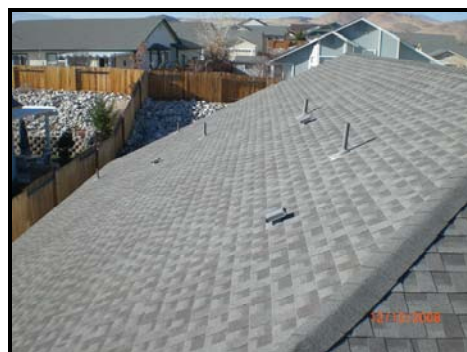
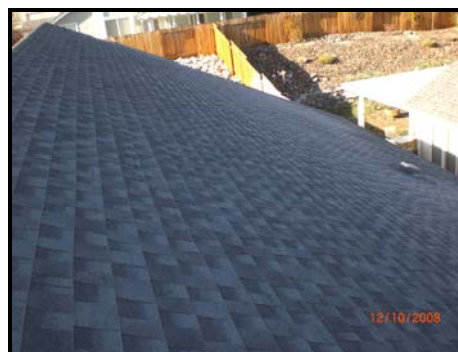
Positive Attributes

The roof coverings are in generally good condition.

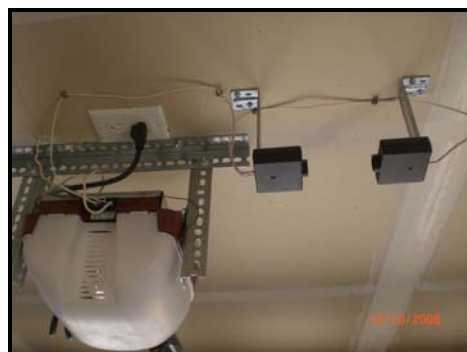
Garage

- **Repair, Safety Issue:** The garage door opener did not automatically reverse under resistance to closing. ***There is a serious risk of injury, particularly to children, under this condition.*** The sensors have been placed in the garage ceiling to bypass this safety feature and allow the door opener to continue to operate.

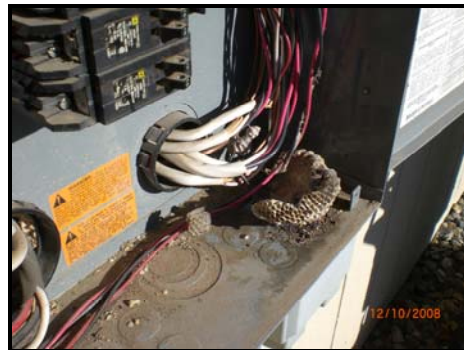
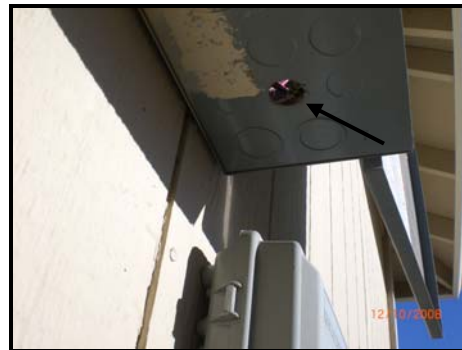
Main Panel

- **Repair:** Any openings in the main panel should be covered. The bottom of the panel has an open knockout which has allowed wasps to build their nests inside the panel.

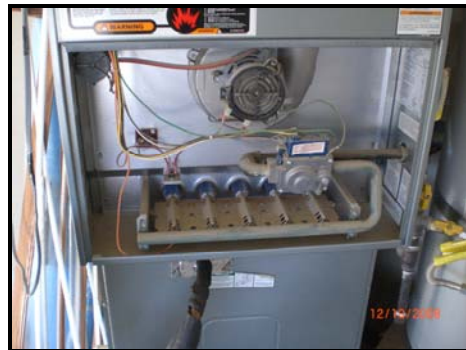
Furnace

- **Repair:** The heating system is dirty and requires cleaning/service. This should be a regular maintenance item to assure safe, reliable heat.

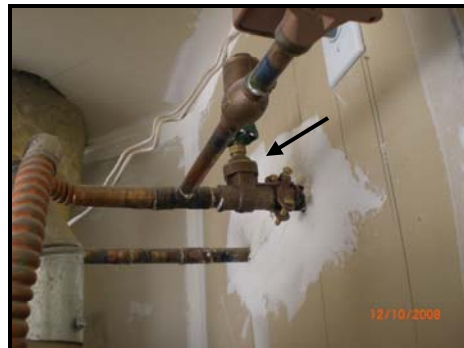
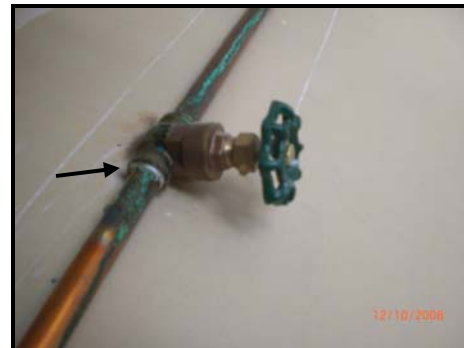
Water Heater

- **Repair:** The cold water inlet valve was leaking at the time of the inspection. The valve off of the circulating pump is leaking and dripping onto the wood below the unit.

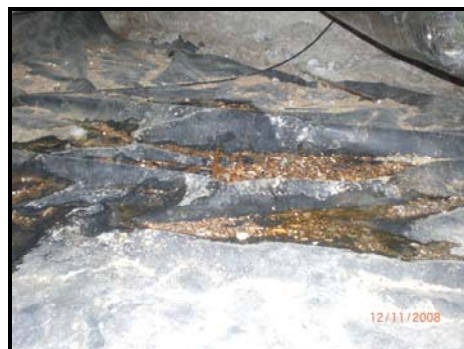
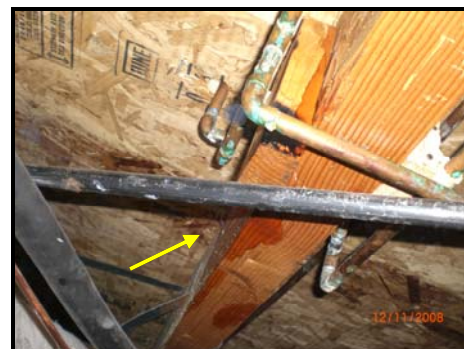
Fixtures

- **Repair:** The utility/laundry room valve is leaking and appears to be leaking down the wall and through the sub floor into the crawl space. The photo on the left is the water from the leak on the vapor barrier.

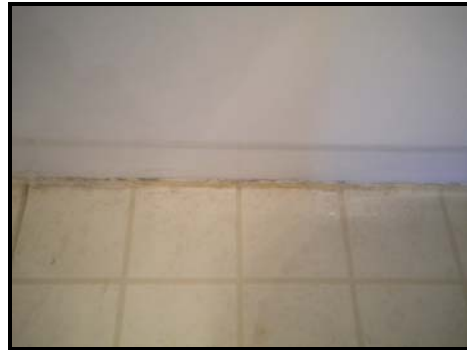
- **Repair:** Cracked, deteriorated and/or missing bathtub enclosure grout and caulk should be replaced in the master bathroom tub.

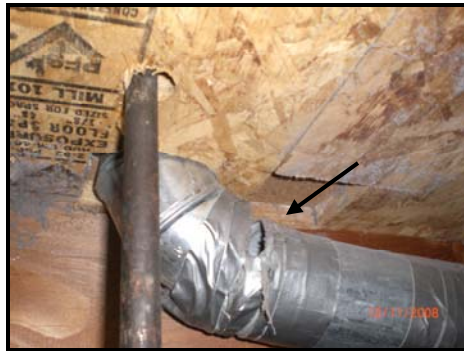
Clothes Dryer

- **Repair:** The clothes dryer exhaust vent pipe has a tear in it and is leaking into the crawlspace. The damper on the exterior vent should be cleaned in order to close properly.

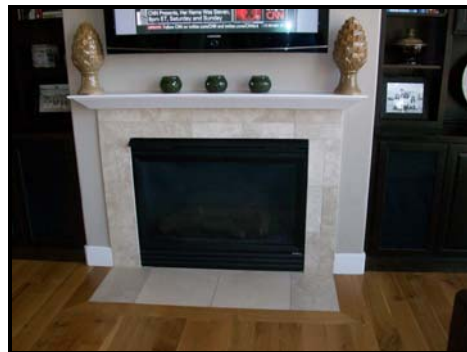
General Comments

The fireplace and its components responded to the operating controls and are in above average condition.
